SITE ASSESSMENT FOR
PRAIRIE PAINT AND ADHESIVES
MAHOMET, ILLINOIS
TDD# 5-8305-21

WESTON-SPER
Technical Assistance Team

June 1983

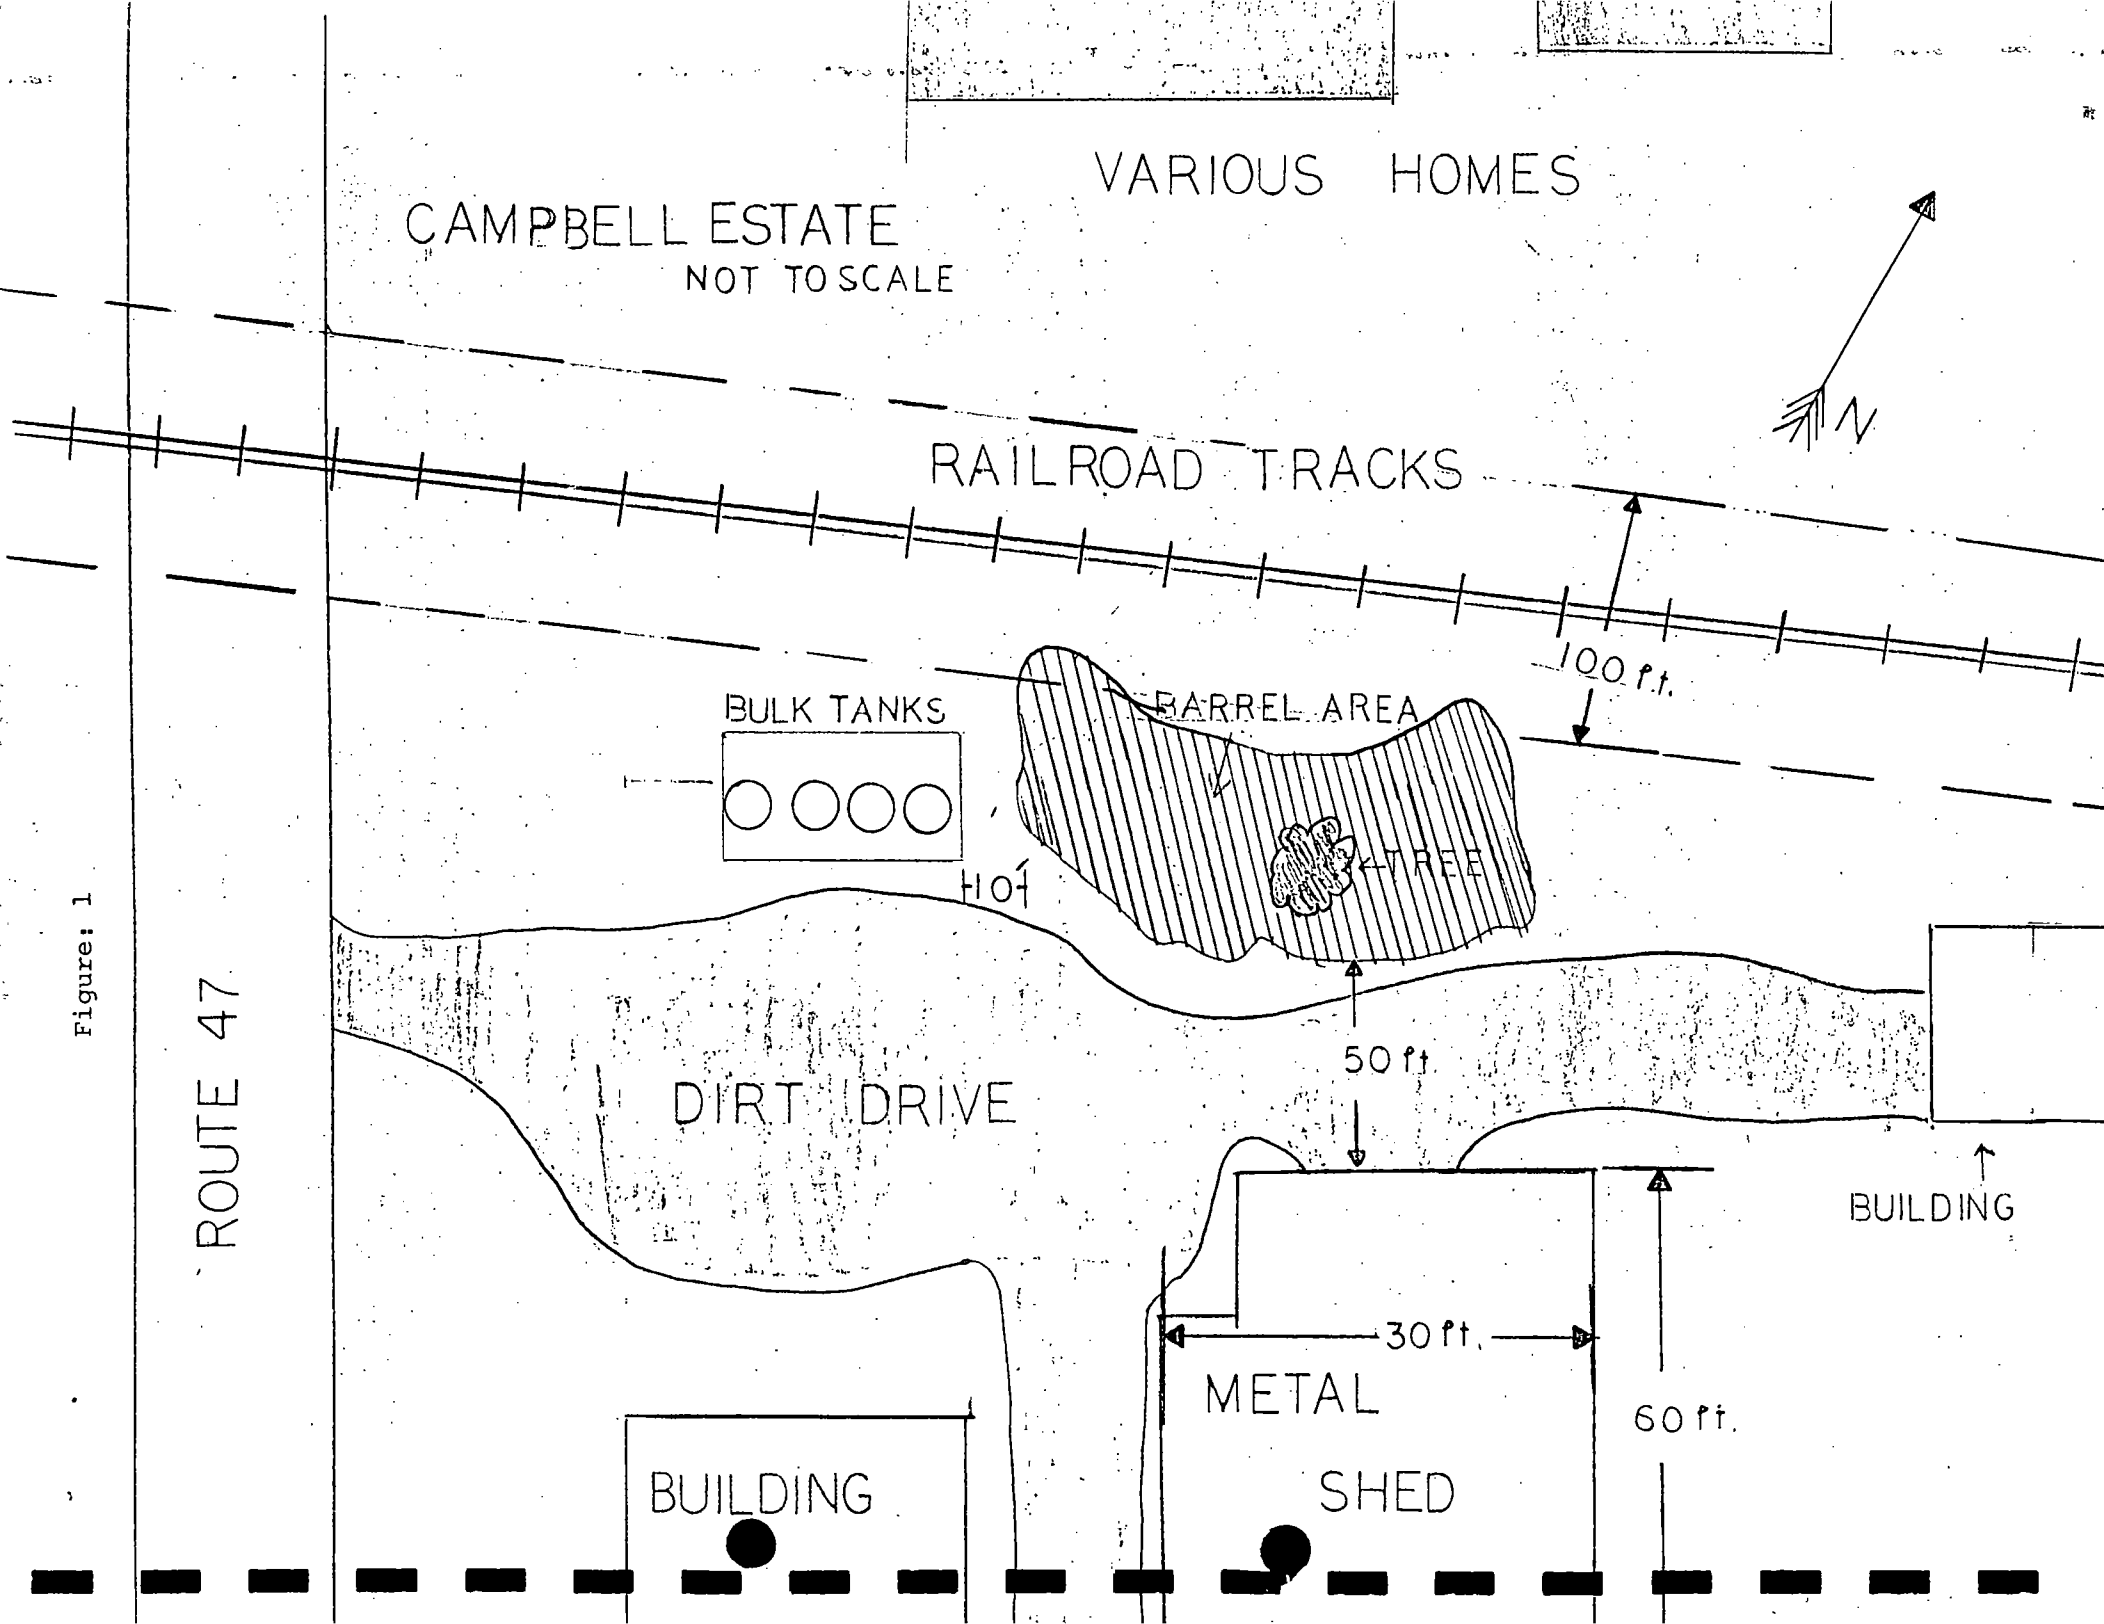
Figure: 1

Further investigation revealed that the 55 gallon barrels were located on 3 different properties, owned by 3 different owners. Some are located on the Peoria & Eastern Railroad land. Some are on Lot #2 which belongs to the Campbell Estate. The rest are on Lot #3 which belongs to Alpha Material Company (now apparently known as Central Material Co.). A map showing the site locations is shown in Figure 1.

The site (Figure 1) is bordered on the north by the Peoria & Eastern Railroad tracks, State Route 47 on the west, a metal shed on the south, and a small abandoned building to the east. At the time of the site assessment, the only site security was the occasional patrol by the Mahomet Police Department. Adjacent to the site is a small bulk storage facility operated by Parker Oil and leased from Alpha Material Company (Central Material Co.) controlled by Mr. James Acheson. Some of the barrels were as close as 10 feet from the bulk tanks. The Sangamon River flows south along the east site boundary approximately 1/4 mile from the barrels. The Sangamon River flows into the Illinois River.
